ጣና ተፋሰስ የተቀናጀ ልማት በጎ-አድራጎች ድርጅት  
Charitable Organization for Integrated Tana Basin Development

## Evaluation of Water Hyacinth Harvester and WH Management of Lake Tana, Ethiopia

June 2018

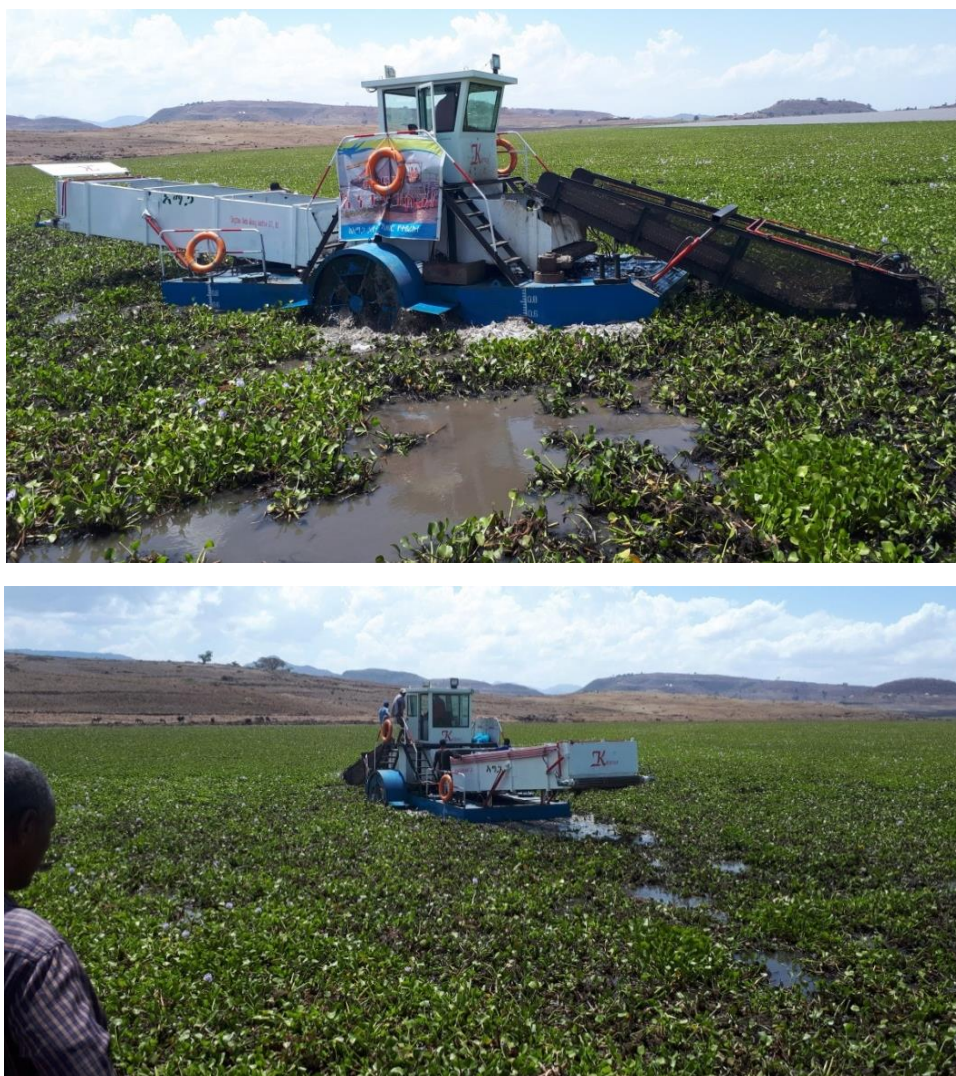
Figure 4: WHH donated by Amaga (Photo by COITBD team)

The WHH currently undertaking the removal WH (Figure 4) is with two cutters at the front (right and left) and pulling out the WH from the lake through metal conveyor chain to the collecting cart. Once the harvester loads the WH on collecting cart with a capacity of 20m<sup>3</sup> and positioned on the back of the WHH, it moves back closer to the shore and disposes the weed right near the shore.

Since it dumps the harvested weed near the Lake, it is very likely for the weed to be back into the lake, with the rise of the lake level and rainfall. This would also aggravate the re-infestation and spread of the WH in the Lake, if it gets back. Hence disposal of the WH is one critical aspect which needs much attention. In this regard three main options could be proposed for resolving the existing limitations of the disposal of WH.

1. The harvested WH should be transported to a furthest disposal place from the lake, by preparing a dumping site. For instance, trucks could be used which probably would help transport starting from the Lake to the dumping place. Another option for transportation could be using the self-propelled wheeled side tip sugarcane buggies which have been successfully used to transport the WH. However, care must be taken when side tipping as it is designed to lean against a cane bin and could topple. In addition, wet water hyacinth can be compacted/ chopped to reduce the water content prior to transportation, which can help to reduce transportation costs. If is directly being moved off-site, material can only be removed in a sealed truck to avoid leakage or spillage and may require a permit for transportation from the concerned government agencies.

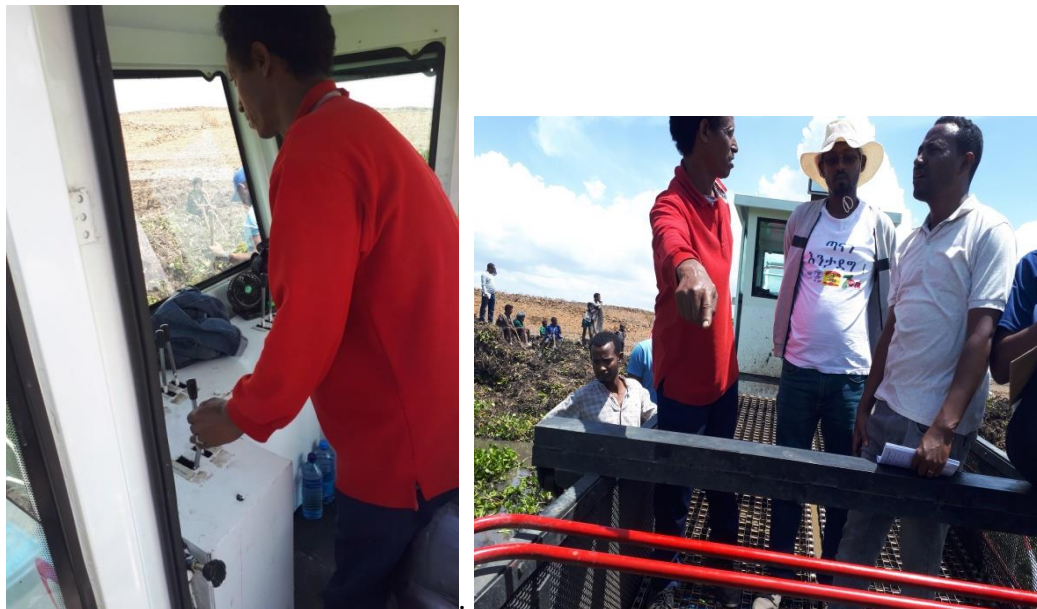
Figure 5: The captain operating (left) and explaining about the machine for some of the team members (right)

The proposed working hour of the WHH is from **8:00 AM morning to 4:00 PM in the afternoon. However, due to its frequent problems, it was not able to work full hours. Till now, the maximum working hour of the WHH was only 4 hours and commonly 3 hours per day. On average, one captain works from 1.5-2.5** hours and is replaced by the

two co-captains interchangeably. With its maximum operation capacity, the WHH does remove nearly 40 full back box (20m<sup>3</sup>) “biajo” of WH in an hour. After the daily working hours, the crew performs cleaning, greasing and stationing the machine in appropriate place. With the limited training and the challenge associated with the machine such as repeated failure and poorly supplied spare parts, the operator’s skill to work with WHH looks good. After some time operation (two hours working), the engine of WHH heats up. . For this reason, it was not able to move around by carrying the full volume of the WH. During such difficulties, the operator dumps part of the harvested WH in to the lake and disposes half out of the lake near the shore. Some additional challenge of the current WHH faced which was understood from the observation of the team and the discussion with key informants includes;

1. The placement of fuel and oil tanker in only on one side. This hinders the filling up of fuel, as it creates an in-balance of the WHH during operation.
2. The WHH motor is open and below the WH transferring conveyor chain. Which make it susceptible for water to enter in to the motor and exposed for failure of motor
3. There are cases where the conveyor chain jumps over and creates problem in operation

1. The very dense nature of WH and the substrate it creates with the mud makes it hard to cut and transport in to the chains. Before the WHH tries to load the WH, there should be chopper machine or fitted blade which cuts the dense part of WH in to pieces to easily pick by the WHH.

2. The problems related to the fuel tanker and the motor of the WHH position need to be resolved to adjust the balance and weight. This would help for easily operating and preventing the motor from failure.
3. The operation and maintenance manual needs to include the whole part of the WHH, not only the motor. But the manual that is available with the machine is only a manual for the engine.
4. Some of the critical operation and maintenance issues need to be translated in to local language for the crew members to refer it any time they face problems.

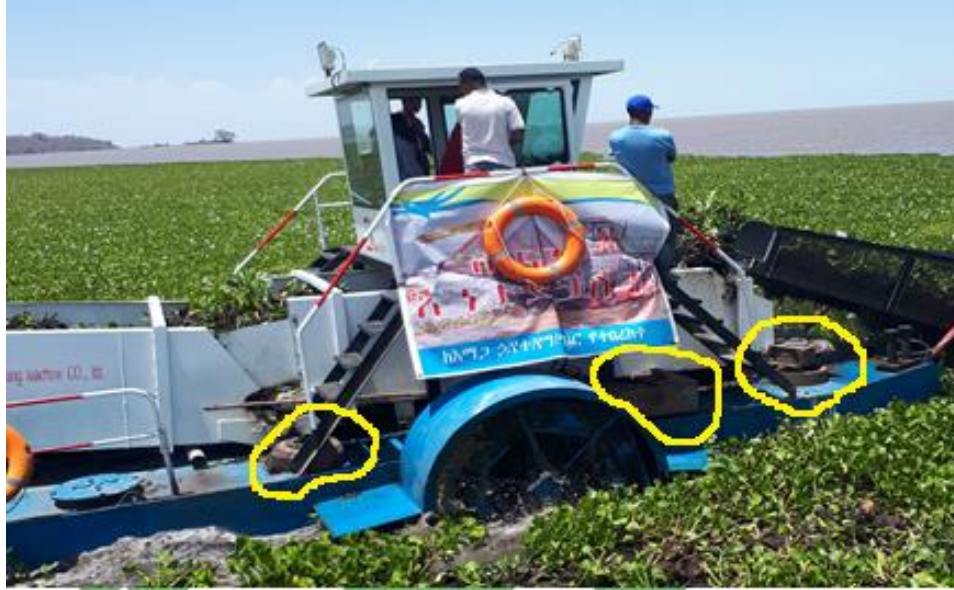
Figure 7: The materials added such as bricks and stone (marked in yellow) in the right part of the harvester to balance the fuel tank on the other side of the WHH.

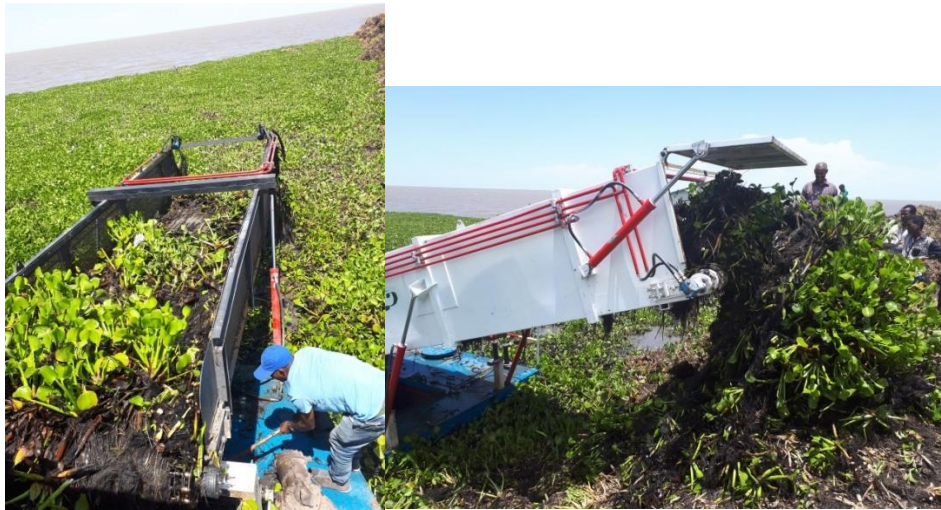
The current WHH with storage cart full (at back) collects 20 m<sup>3</sup> of WH. It took 15 minutes to collect and dispose this amount. In one hour it would collect and disposes 80 m<sup>3</sup> of WH. In one day (working for maximum of 8 hours), it was estimated to collect 640 m<sup>3</sup> of WH. The WHH is capable of clearing a dense WH area of 40 m<sup>2</sup> in one hour. The WHH machine performs in slow speed and sometimes stacks while working, due to less power to penetrate the dense WH.

Figure 8 WHH loading the water hyacinth from Lake Tana (Left) and disposing near the shore (right)

WHH disposes the WH near the shore along with the lake water (Figure 8). There is no prepared specific disposal site. The cutter installed in the front part of the WHH cuts the WH from the bottom once and transfers to the back box part by using the conveyor made from metal chain. Both the WH removed by hand through community campaign has got dried. This was due that the when the lake water recedes due to lowering of water level. Similarly part of WH removed by the harvester was dried but not enough like later one. From the Authority, zonal experts and community it was understood that there was a plan to burn the dried WH with fuel gas partially distributed by the woreda and in rare cases the team observed the burned WH (Figure 9). This is to prevent the re-

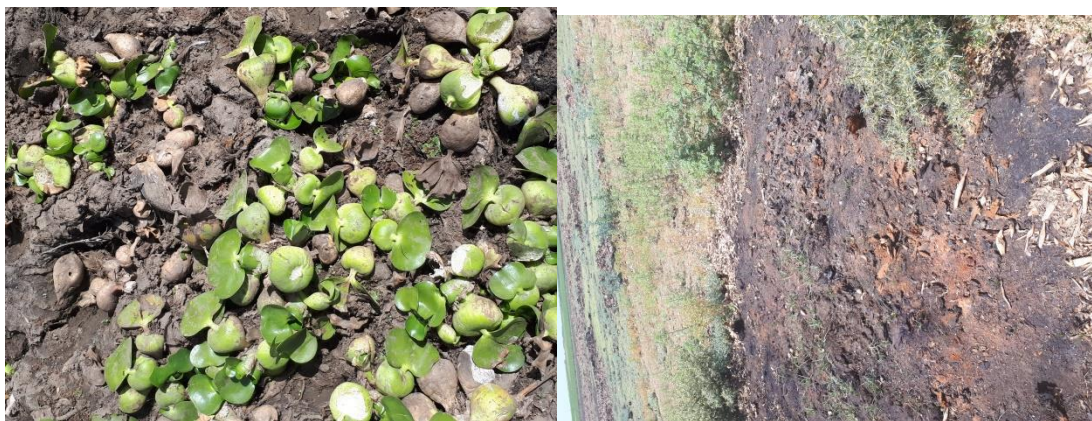
production of the water hyacinth when it gets moisture by rainfall or when the lake water level rise back. Still large volume remains there and showed a tendency to re-grow (Figure 9). It was because of the very few amount of gas for the community was distributed by the woreda to burn the dried out WH.

Figure 9: Disposed Water hyacinth remain in the wetland and growing again (left) burnt Water hyacinth (right)

2. Water hyacinth has been known to survive for months in mud away from water. Harvested plants must be either buried nearby on site or piled away from the shore line, above the flood level and spread out to dry completely or left in piles to decompose. Due to the high-water content in water hyacinth, piles will leak water for some time. To stop water from flowing back into the water body, taking viable seeds and other contaminants with it, it may be necessary to bund the piles.

3. Keeping the WH in the field far from the shore in common place for some time and waiting till it get dry and then burning with fuel gas. This could be efficient if the community under EWLPDA monitoring where they should help the WH to dry by letting the sunlight in every piece of the WH. In this case efficient distribution of fuel is critical. Currently this approach has is being practiced with very few farmers due to shortage

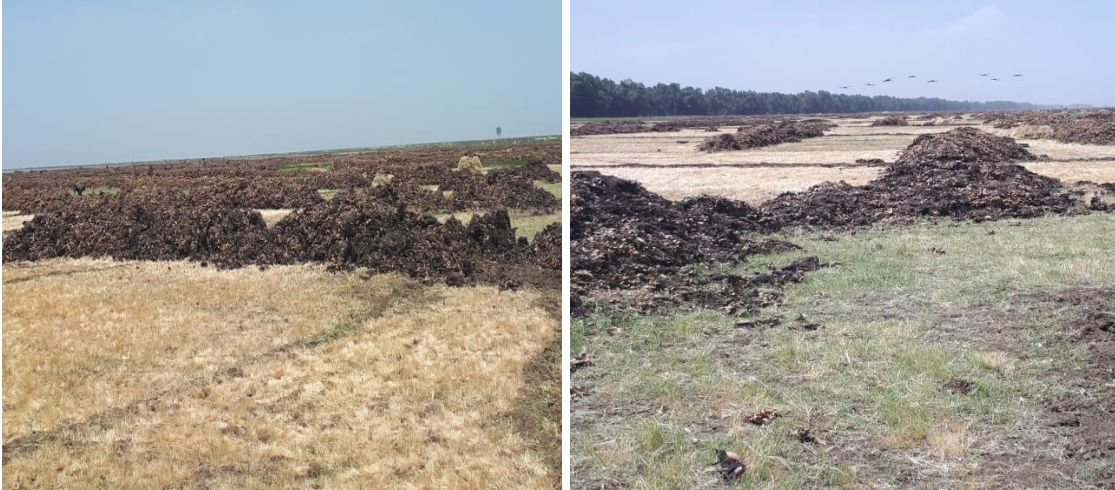
The community has been struggling with water hyacinth since the 2011 by hand removal in annual mass campaign every year from December -February. Especially this year the campaign has started in October/2018 in every Kebele till March 2018. This times was early in terms of starting which previously was in late December to March every year since the WHH have been observed. Due to this years extended period campaign of WH removal the most affected areas has become free from the water hyacinth. For instance in the Achere kebele the WH coverage has not been completely removed since 2011. This year the community managed the WH removal nearly 100 % and it was disposed in the wetland and farming land (Figure 10). The disposed and accumulated WH in the agricultural land has reduced the farming land of the community. This ultimately has decreased the agricultural productivity. Upon discussion with the community, they warmly welcome the arrival of the machine. They emphasize that upcoming WHH should at least help work of WH removal in areas where the human being is unable to do easily. The community promised to work hard in our discussion. But still they need help in areas which are the difficult to remove the WH due to depth of water (above human height) and community afraid of the harmful aquatic animals.

Figure 10: The removed WH from the lake water in the framing fields

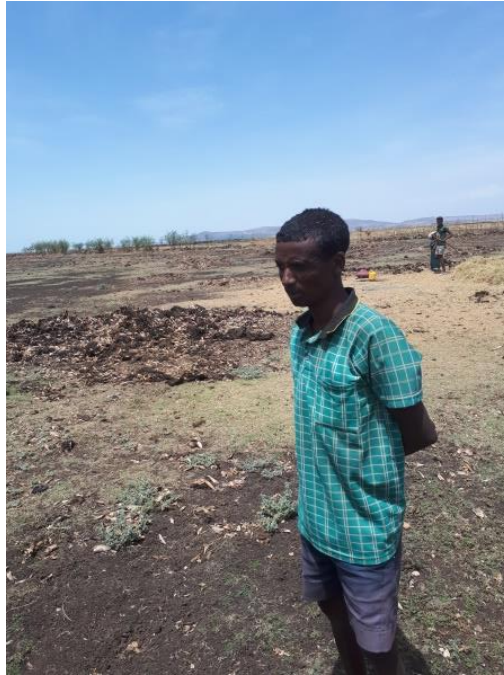
When the lake level increases the line WH will move out with water and cover decent amount of farmlands. Where the area covered by the WH above water could not provide yield as it prevents the crops to get sunlight as well as damages it mechanically. As the result the farmers faced challenge to their livelihood. To reduce this problem very few farmers installed fence around their farmlands to prevent the entrance of WH with the lake water. Hence the can help to grow water loving crops such as rice and hence obtained optimum yield than the other farmers whom exposed their farmland without fencing it. For instance in Achere Kebele farmer named by Ademe belay (Figure 11) did the fencing before the lake water rise and covers with WH. On account of this he was able to produce 2500 kg of rice /4 acre of land. In addition his fence has saved the farmlands of other 10 farmers neighboring to his farmland and they were able to able to produce rice. The experience observed from this brave farmer was appreciated by most farmers. Each farmers plan to follow the footsteps be implemented in their farm land. It was also suggested that fencing along the shore could help them to produce rice by protecting the WH entrance to their field. Our team has appreciated the farmers' effort to produce rice by fencing their farmland. It was also reached an agreement that with

fencing of some places it at least could reduce the impact of WH on the farmlands and help them to produce rice on the flood plain.

Figure 11: The farmer who started fencing to prevent the effect of the WH on farmland

7. As part of mechanical method of WH reduction mechanism the Fence near the shore in some areas need to be implemented to prevent the farmers cultivated land before it damages the rainy season production.

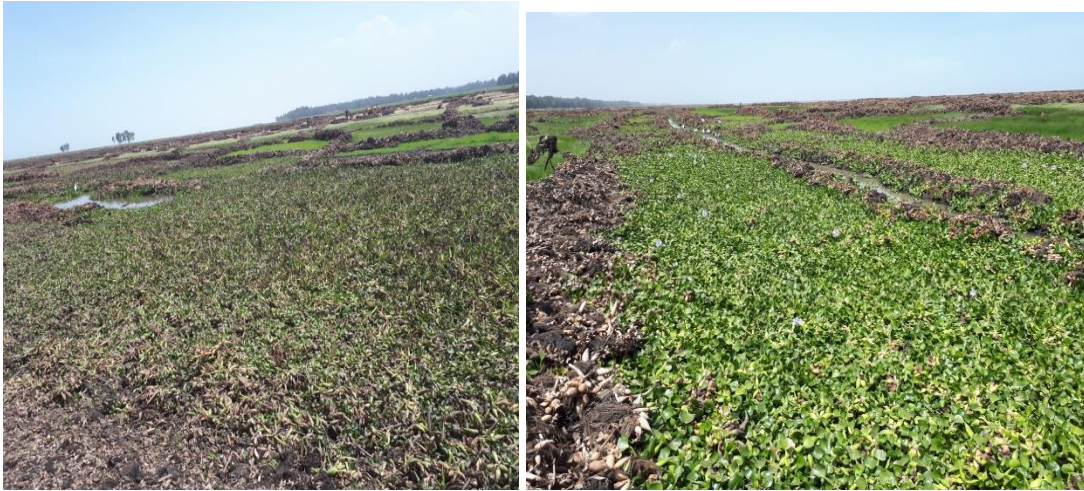
It is absolutely important that WHH was critical for the removal of the weed from Lake Tana. However the type of the harvester to be deployed need to be in line with the nature of the lake shore in each kebele. This varies across kebele differently. In some part of the lake shore and the ground are flat and in others there is clear barrier between the lake water and the shore with boundary. In some of the other parts it is connected to the wetland and the recession of the lake water is with the wetland. In Fogera area where the shore and the wetland are plain type with much sediment near the shore (Figure 12), the amphibian harvester (which works both on water and land) is very important. In addition to collecting the WH it just cuts WH in to pieces pushes out of the lake water and the muddy sediment deposited wetlands. Moreover these areas in places where the WHH couldn't reach due to low water level and wetland the fence

near the shore should be installed to hinder the movement of the water hyacinth to the farmlands could be considered.

Figure 12 WH in Fogera area with the lake shore and the wetland is plain level

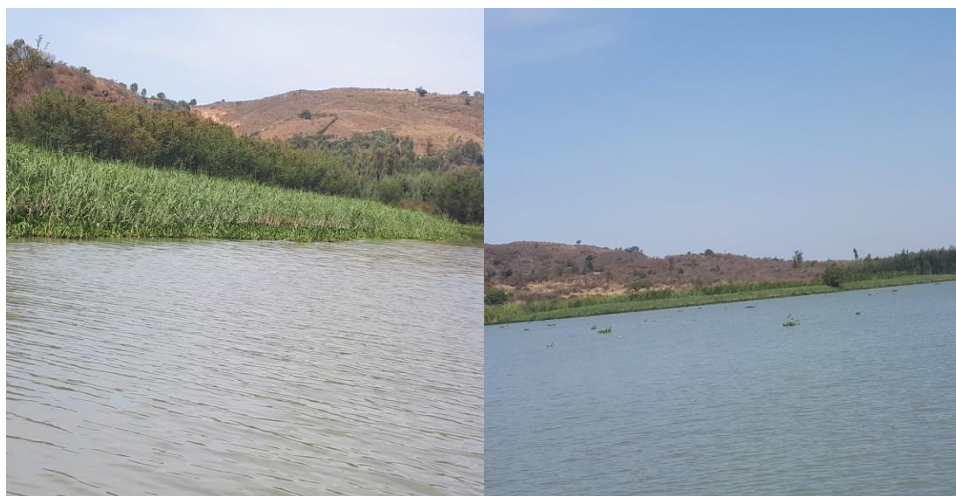
In Kebeles such as Gorgora and Sheha Gomengie the WHH with chopper is recommended (Figure 13). This is due that the nature of the water hyacinth is very thick and dense where the community needs help. In addition the shore of the lake at this positions not plain with the wetland. It has clear boundary and depth where the hand pick removal is difficult.

Figure 13 Water hyacinth in Gorgora kebele (left) and Sheha Gomengie (right)
